Functional Differences Between MSC8101 (Mask 2K42A) and MSC8103 (Mask 2K87M)

This document describes the differences between MSC8101 mask set 2K42A and MSC8103 mask set 2K87M. These differences include:

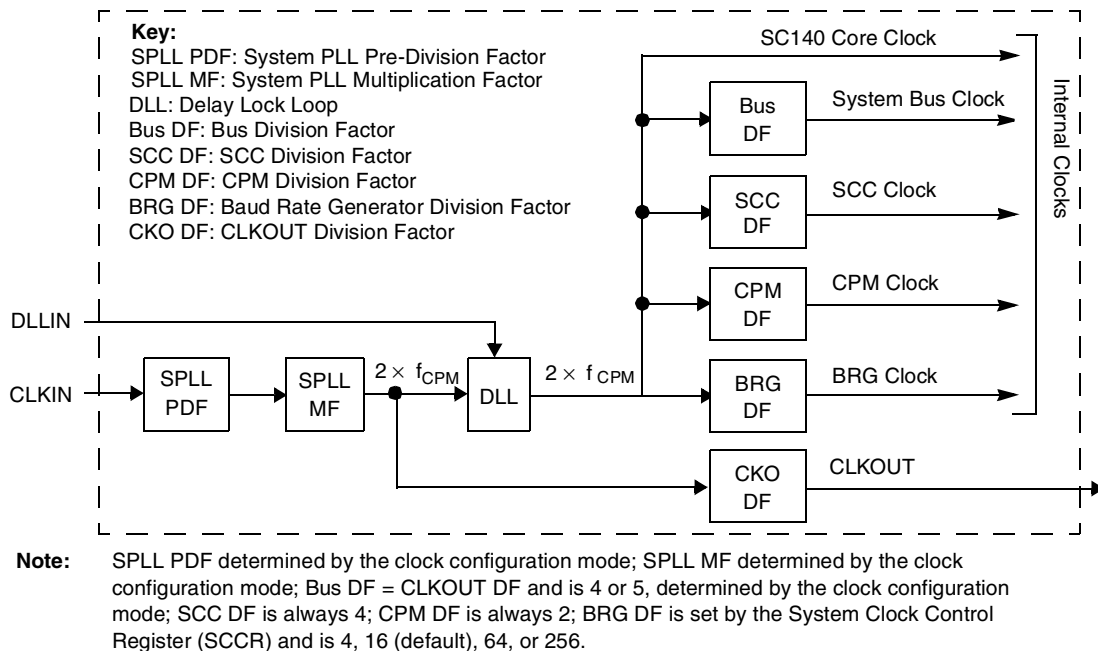
Figure 4. MSC8101 Clock Functional Block Diagram for 2K42A Mask Set

Figure 4 shows the functional block diagram for the 2K42A mask set. The 2K42A mask set contains an internal system phase-locked loop (SPLL)

The SCC division factor (SCC DF) is fixed at 4 and the CPM division factor (CPM DF) is fixed at 2. The BRG division factor (BRG DF) is configured through the System Clock Control Register (SCCR) and can be 4, 16 (default after reset), 64, or 256.

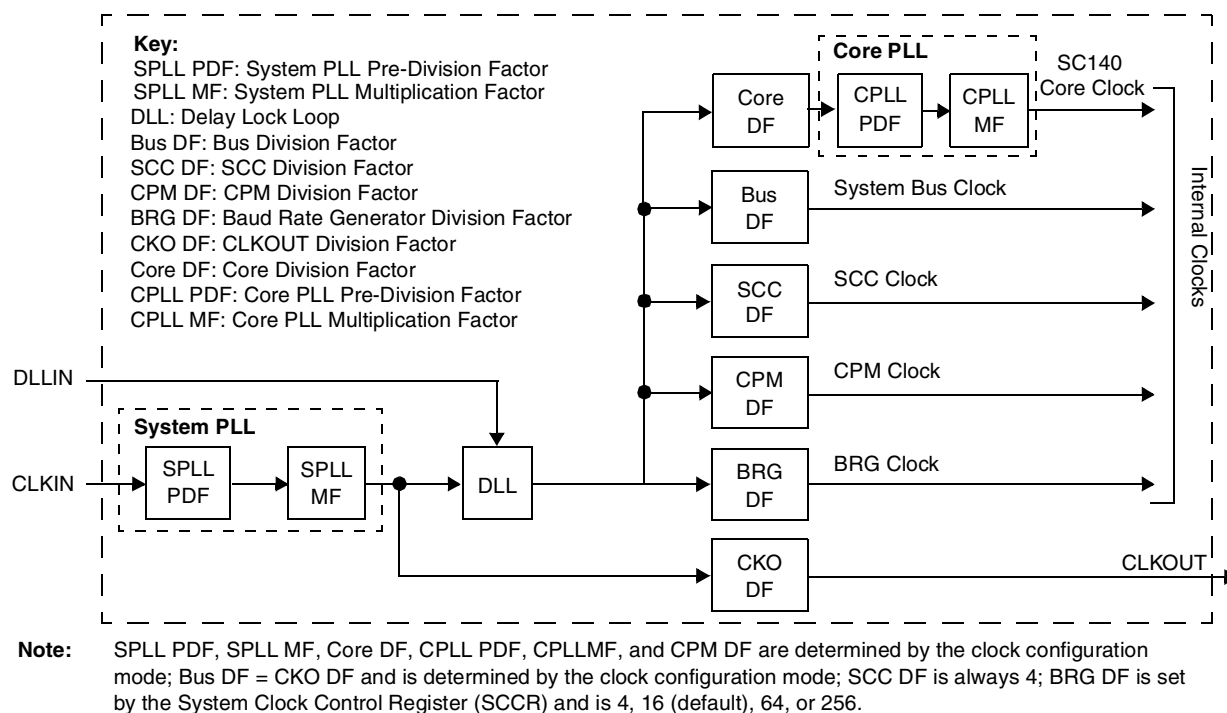
Figure 5. MSC8103 Clock Functional Block Diagram for 2K87M Mask Set

- SPLL pre-division factor (SPLL PDF)
- SPLL multiplication factor (SPLL MF)
- Bus post-division factor (Bus DF)
- CPM division factor (CPM DF)
- Core division factor (Core DF)
- CPLL pre-division factor (CPLL PDF)
- CPLL multiplication factor (CPLL MF)

Figure 5 shows the functional block diagram for the 2K87M mask set. The 2K87M mask set contains an internal system phase-lock loop (SPLL) and a core phase-lock loop (CPLL).

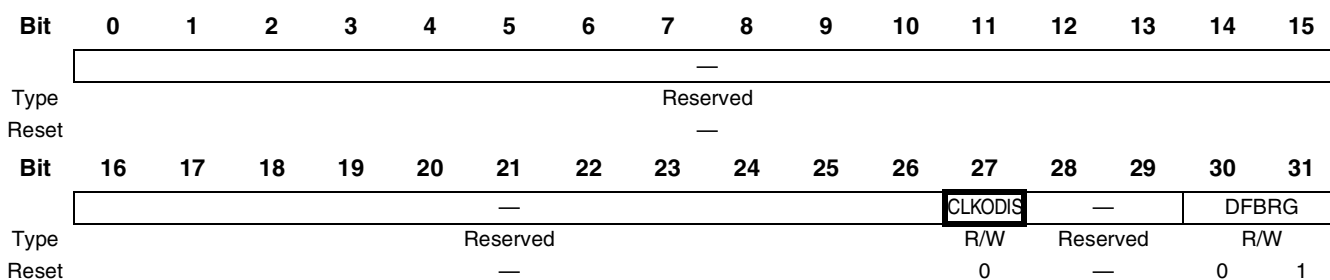
Figure 8. System Clock Control Register (SCCR)—0x10C80

The 2K87M mask set adds a new field (CLKODIS) to the SCCR. The functionality of the common field (DFBRG) is the same. **Figure 8** shows the register layout and **Table 12** lists the bit descriptions.

Name Bit No.	Defaults		Description	Settings
	PORESET	Hard Reset		
— 28–29	—	—	Reserved. Write to 0 for future compatibility.	
DFBRG 30–31	01	Unaffected	Division Factor for the BRG Clock Defines the BRGCLK frequency. Changing this value does not result in a loss of lock condition.	00 Divide by 4 01 Divide by 16 (default value) 10 Divide by 64 11 Divide by 256

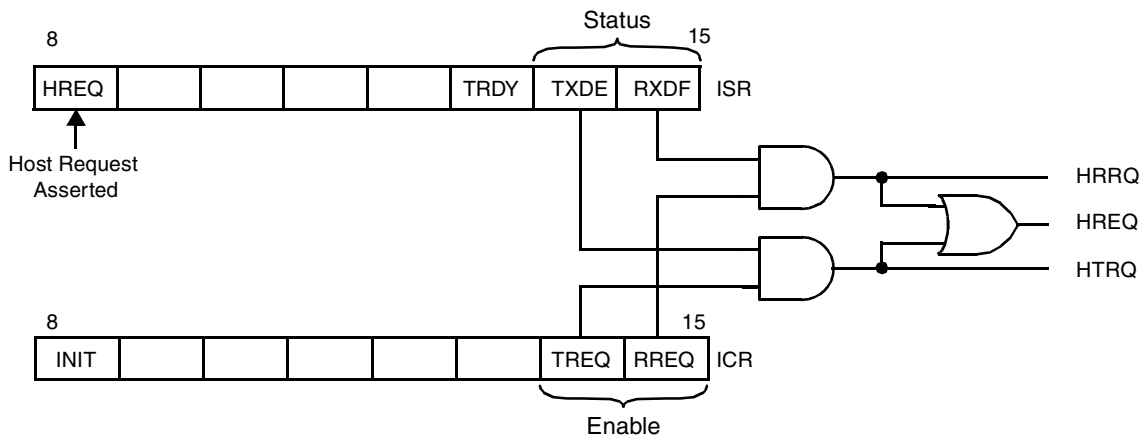
Figure 9. HDI16 Host Request Structure

When HREQ is connected to the host processor interrupt input, the HDI16 asserts HREQ to request service from the host processor. HREQ is asserted when TXDE is set and/or ISR[RXDF] is set, and the corresponding enable bit (TREQ or RREQ, respectively) is set, as **Figure 9** shows.

The host processor acknowledges host interrupts by executing an interrupt service routine. The host processor tests ISR[RXDF] and ISR[TXDE] to determine the interrupt source. The host processor interrupt service routine must read or write the appropriate HDI16 data register to clear the interrupt. HREQ is deasserted under the following conditions:

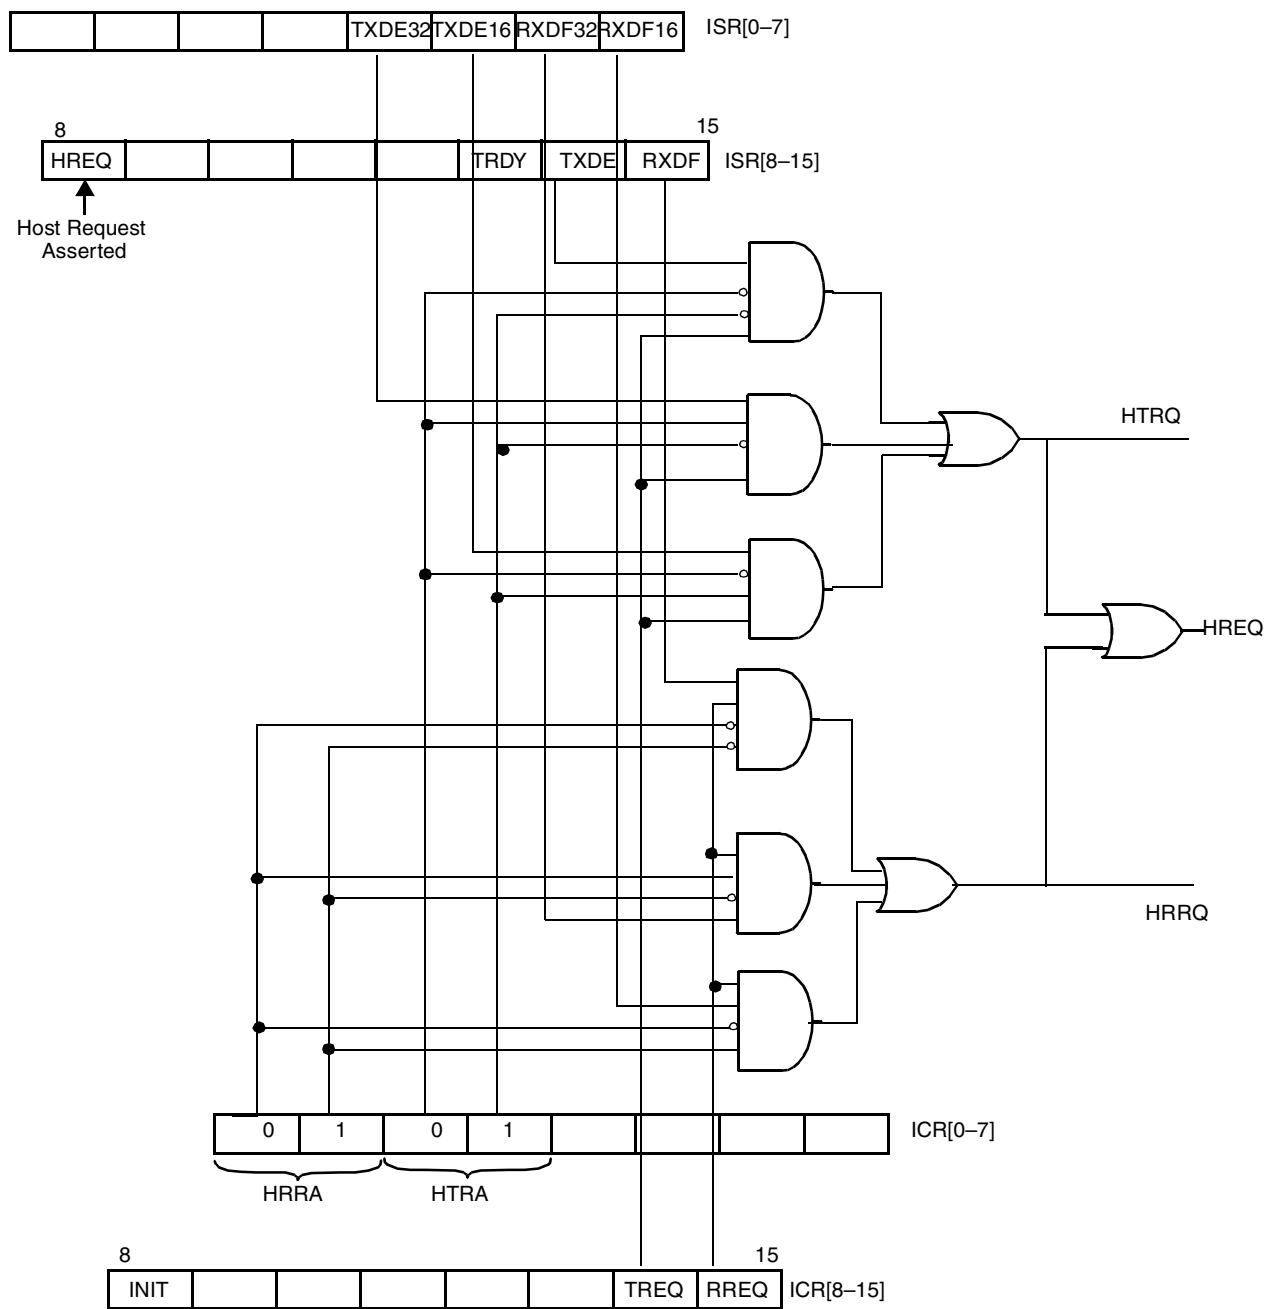
Figure 10. HDI16 Host Request Structure

When HREQ is connected to the host processor interrupt input, the HDI16 asserts HREQ to request service from the host processor. HREQ is asserted according to the programming of ICR[HTRA] and the status bits TXDE, TXDE16, and TXDE2 when ICR[TREQ] is set, or according to the programming of ICR[HRRA] and the status bits RXDF, RXDF16, and RXDF32 when ICR[RREQ] is set, as **Figure 10** shows. The programming of HRRA or HTRA chooses the status bit, and depending on its value, HREQ is asserted or deasserted.

The host processor acknowledges host interrupts by executing an interrupt service routine. The host processor tests the appropriate status bit (TXDE, TXDE16, TXDE32, RXDF, RXDF16, or RXDF32, depending on the application) to determine the interrupt source. The host processor interrupt service routine must read or write the appropriate HDI16 data register to clear the interrupt. HREQ is deasserted under the following conditions:

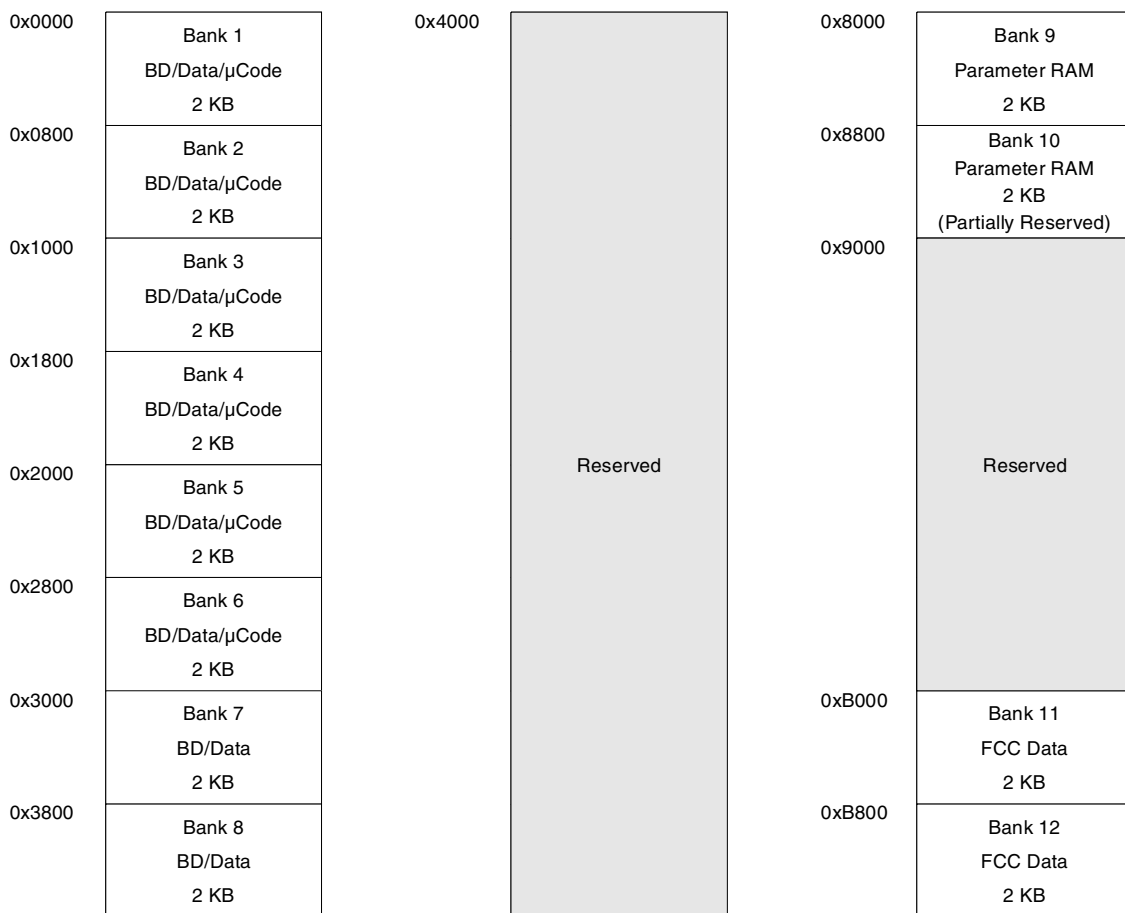
Figure 11. 2K42A Mask Set 24 KB Dual-Port RAM Memory Map

Figure 11 shows the MSC8101 2K42A mask set memory map of the dual-port RAM.

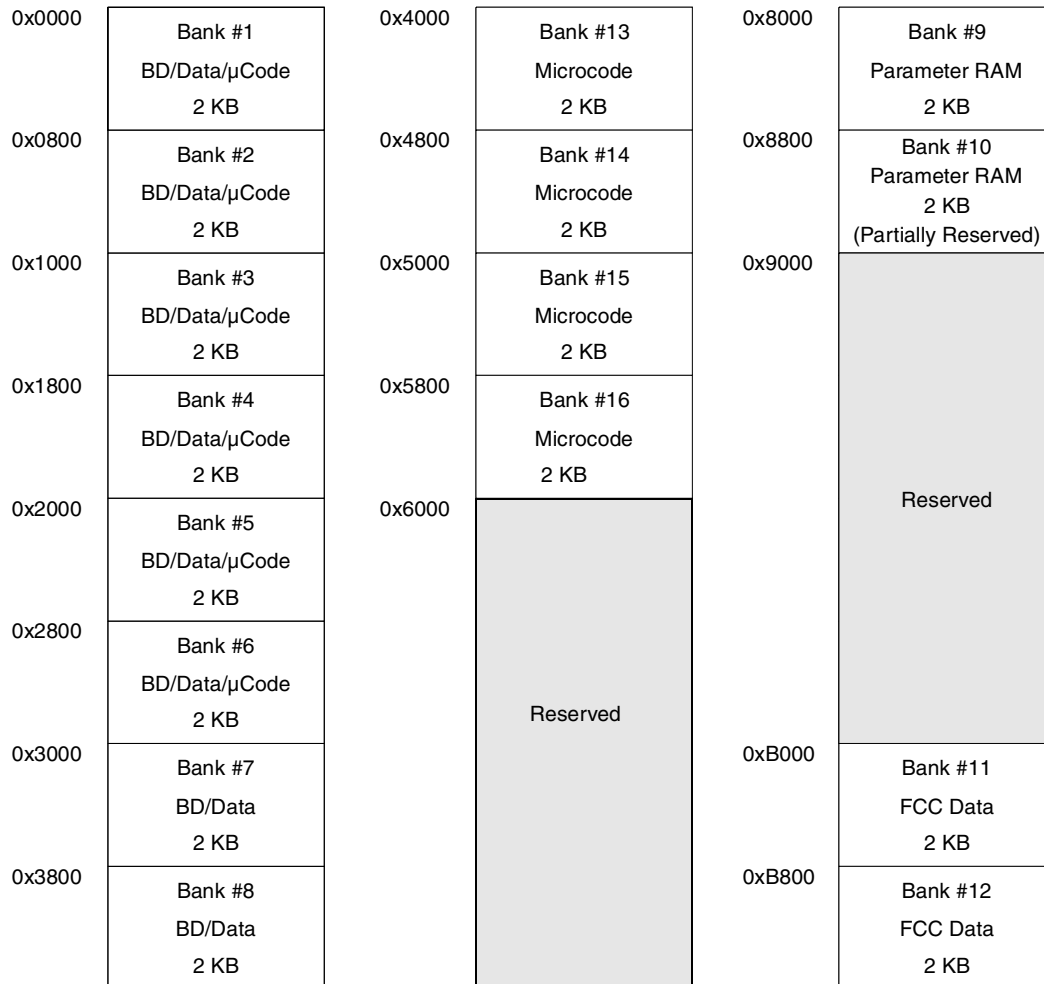
Figure 12. 2K87M Mask Set 32 KB Dual-Port RAM Memory Map

Figure 12 shows the MSC8103 2K87M mask set memory map of the dual-port RAM.

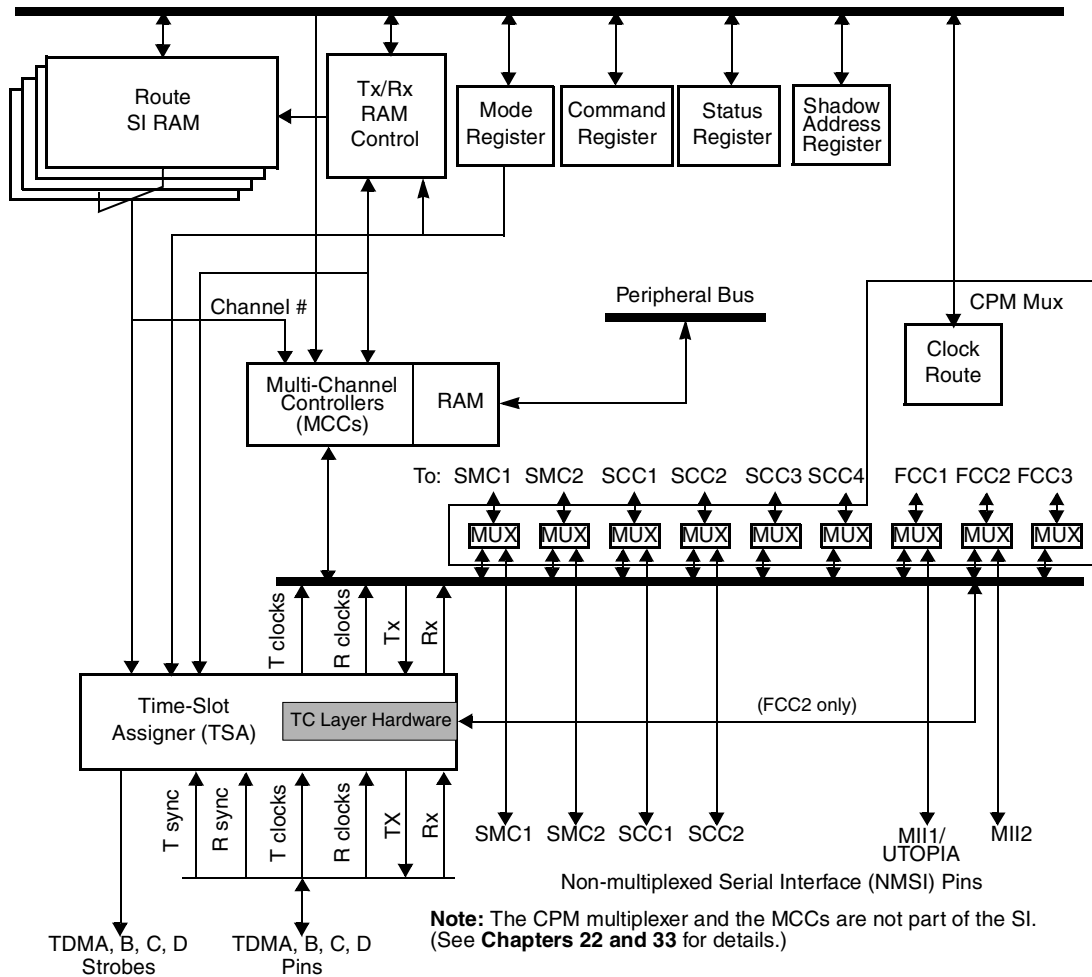
Figure 13. SI Block Diagram

Figure 13 shows a block diagram of the SI blocks and TSA. The TSA also contains transmission convergence (TC) layer hardware.

Note: TC layer support for ATM (FCC2 only) with TC layer 1 supported through TDMA1 and TC layers 6–8 supported through TDMB2, TDMC2, and TDMD2, respectively.

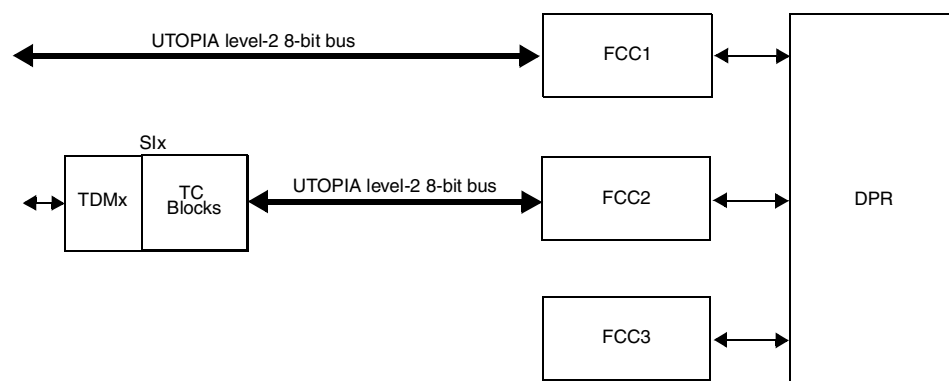
Figure 14. Serial ATM Interface Using FCC2 and TC blocks (single channel)

The MSC8103 supports applications that receive ATM traffic over the standard serial protocols like E1, T1, and xDSL via its serial interface (S_{ix} TDM_x and NMSI) ports because the ATM TC-layer functionality is implemented internally. This allows the use of standard low-cost PHY devices in system applications instead of PHYs that support UTOPIA bus devices. A typical TC layer application requires the use of one SI TDM channel per TC block.

As shown in **Figure 14**, all TC blocks are internally connected to FCC2. In addition, **Figure 14** shows FCC1 connected to a UTOPIA 8-bit MPHY bus that can be routed outside and operated independently from the TC block

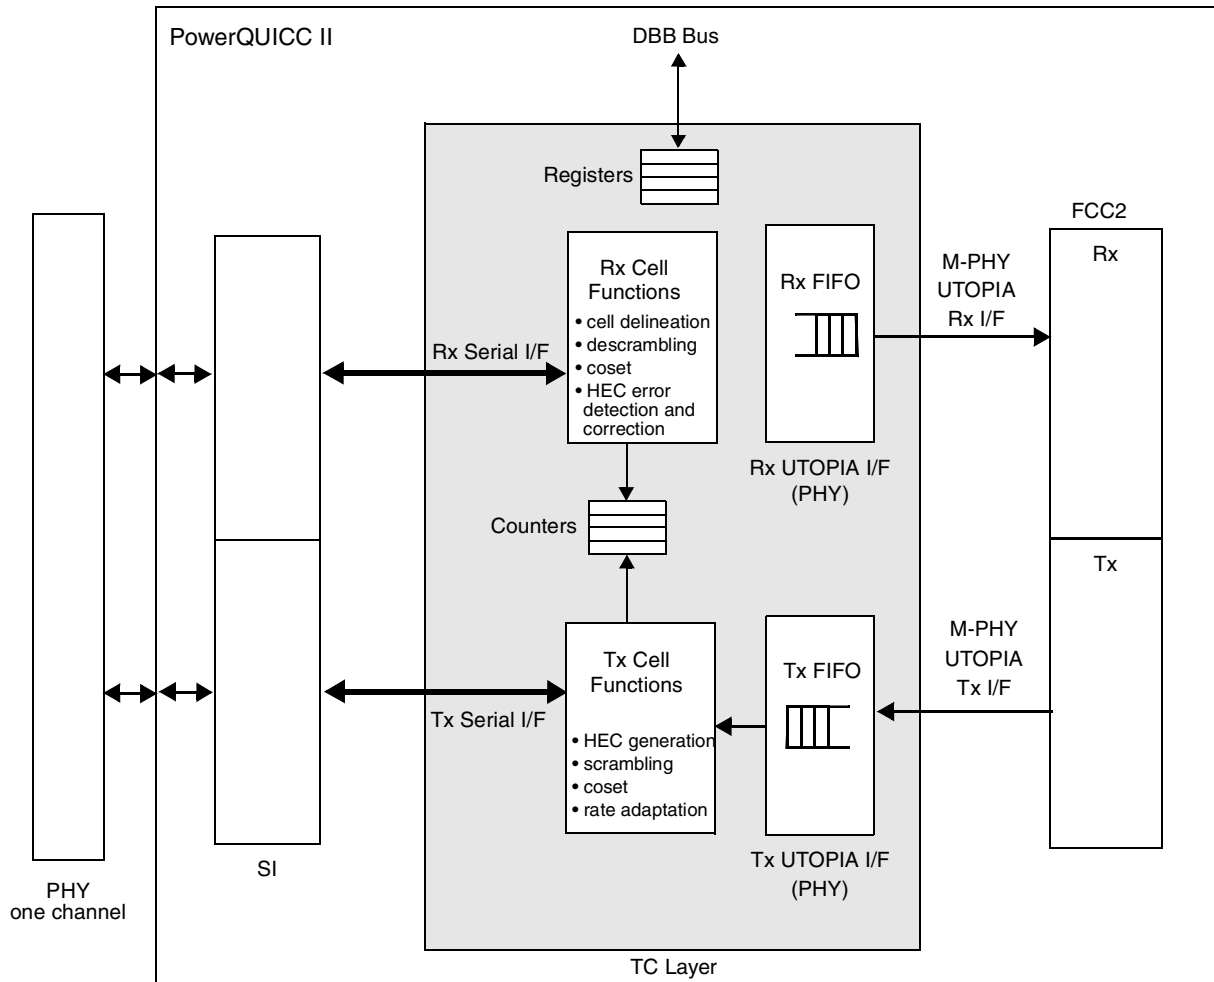
Figure 15. TC Layer Block Diagram

The TC layer block is shown in **Figure 15**. The transmit and the receive parts are independent; the only case in which they are synchronized is in cell echo mode.

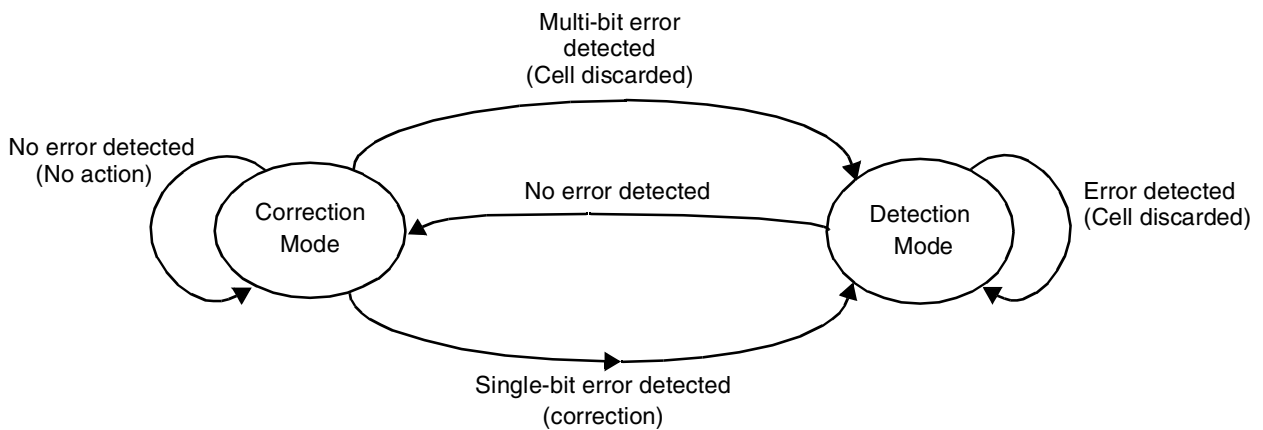
Figure 17. HEC: Receiver Modes of Operation

When the cell delineation state machine is in the SYNCH state, the HEC verification state machine (see **Figure 17**) implements the correction algorithm. This state machine ensures that a single cell header is corrected at a time. If consecutive cells are detected with single bit errors in their headers, only the first cell error is corrected and the rest are discarded. This state machine reduces the delivery of cells with headers containing errors under bursty error conditions.

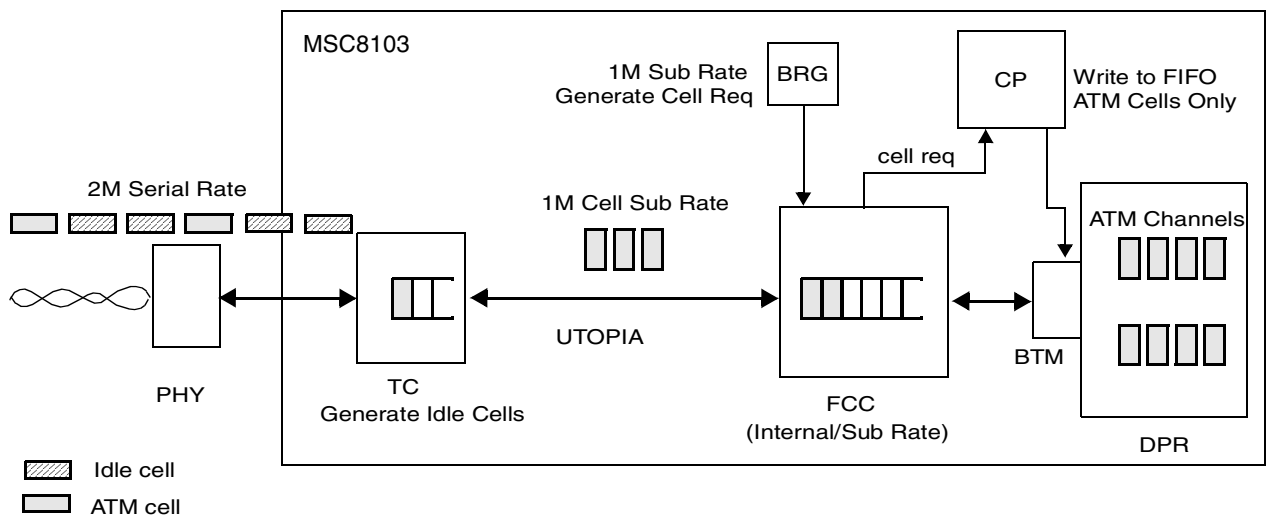
Figure 24. TC Operation in FCC Internal Rate Mode (Sub Rate Mode)

- Internal Rate (Sub Rate).* In this mode, the FCC supplies only four PHY devices that have four distinct addresses. Each channel is controlled by a dedicated hardware timer that is programmed and tuned to the data rate needed. When a timer expires, a valid cell is sent to the corresponding PHY. The PHY sends idle cells to keep its synchronization and transmission rate. The same is true for the TC. Once activated with FCC2 in this mode, the TC requests cells and sends idle cells (UR interrupts can be disabled by clearing TCMODE[URE]) until a valid cell is transferred via the UTOPIA bus from the FCC. See **Figure 24**.

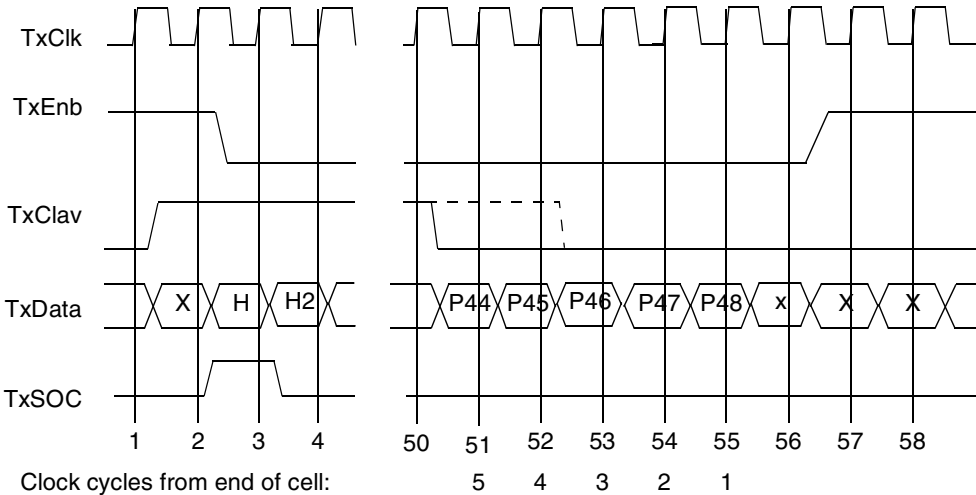
Errata Number	Errata Description	Applies to Mask
<p>CPM101</p>	<p align="center">FCC RxClav Timing Violation (Slave)</p> <p>Date Added: 1/15/2004 Date Revised: 11/05/2004</p> <p>Description: FCC ATM Receive UTOPIA slave mode. When the RxFIFO is full, RxClav is negated 2 cycles before the end of the cell transfer, instead of 4. A master that polls RxClav or pauses 3 or 4 cycles before the end of the cell transfer may sample a false RxClav, and an overrun condition may occur. The dashed line in the timing diagram below depicts the actual RxClav negation (two cycles before the end of the cell transfer instead of four cycles). The signals in the timing diagram are with respect to the master, so the Tx interface is shown.</p> <p>Workaround:</p> <ol style="list-style-type: none"> 1. The master should not poll RxClav or pause a cell transfer 4 cycles before the end of a cell transfer. The master should poll 2 cycles before the end of the current cell or later. This can be achieved by introducing cell-to-cell polling (and transfer) delay, which is equal or larger than one cell transfer time. If this can be achieved, the impact on performance is minimal. 2. Configuring ATM only on FCC1 and setting FPSMR[TPRI] ensures the highest priority to FCC1 Rx. In addition, for CPM usage lower than 80 percent (as reported by the CPM performance tool based on UTOPIA maximal bus rate), the CPM performance is enough to guarantee that the RxFIFO does not fill up.

<p>Clock cycles from end of cell: 1 2 3 4 50 51 52 53 54 55 56 57 58</p>	<p>0K40A 1K42A 2K42A 1K87M</p>
